## DAYCO AFTERMARKET TECHNICAL INFORMATION

**Mitsubishi I4 Timing Drive**

**T00017**

**Eng Code: 4G63, 4G64, 4G69 etc**

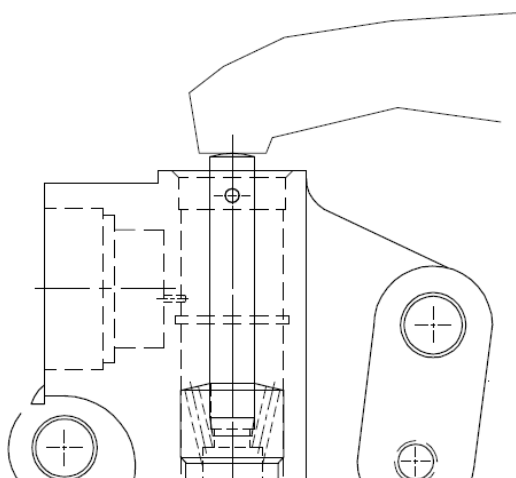
Correct Position

It is also essential that the correct special service tools (SST) referred to in the vehicle manufacturer's procedures are used. This will ensure that the tensioner pulley is set to the correct position in order for the HAT to operate in its intended working range. The correct position for the tensioner actuator should sit such that the interface between the actuator rod and tensioner arm is perpendicular to the direction of travel of the rod. An example of correct and incorrect position is shown below.

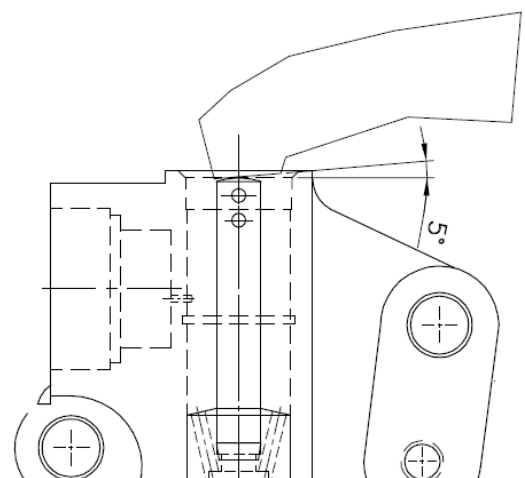
Incorrect Position

If these procedures and SST's are not used, the hydraulic actuator may operate in a range that will not provide the correct tension to the belt. This could cause a timing drive that either becomes noisy in operation or allows the drive to become unstable and lose timing or ultimately lead to failure of the timing drive.

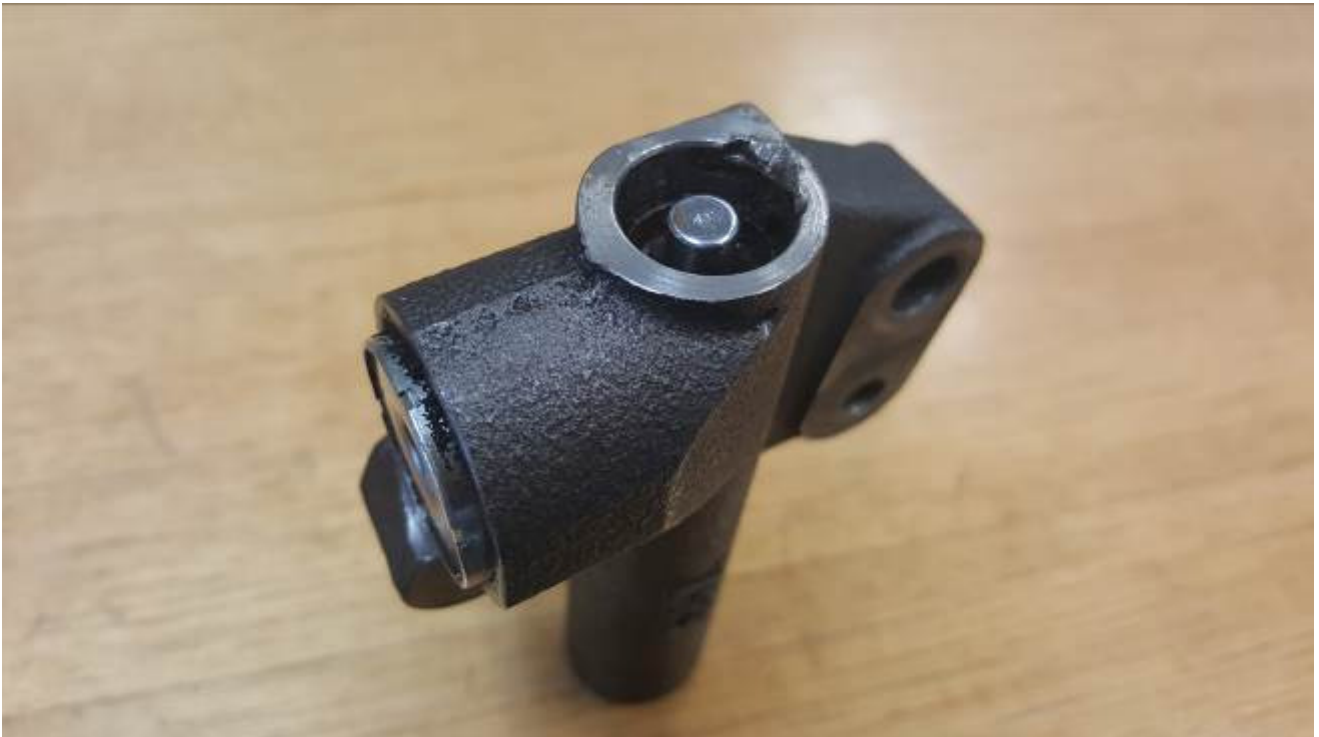
Evidence of HAT failures are actuator rods jammed in retracted position, and hammer marks around the HAT body where the tensioner assembly has come into contact with it. Example of which is shown above.
