DAYCO AFTERMARKET TECHNICAL INFORMATION

KTBA008 Tensioner Fitment Daewoo, Holden

T00005

Engines: A15MF Nubira, A16DMS Cielo & Nubira, F16D3 Barina

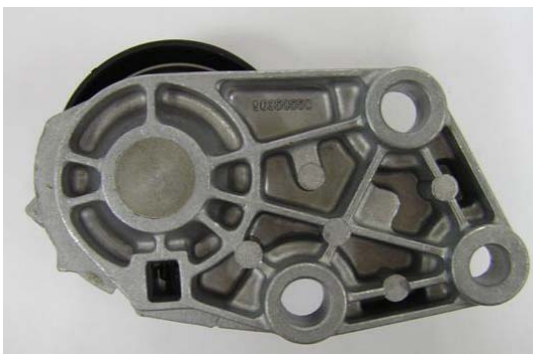
Signs of incorrect tension procedure on returned product

1. Broken tensioner indicator Tab.
2. Witness marks on tensioner end stops.
3. Uneven wear or cracking on outer edge of the pulley surface indicating incorrect tension leading to premature failure.

1. Ensure that the timing marks on the Crankshaft gear and the Camshaft gears are lined up as per the vehicle manufacturer's specifications.
2. Remove the water pump and replace the seal that is supplied in this seal kit. This will avoid leakage of the pump when the seal is interrupted in the timing belt adjustment process.
3. After fitting the new timing components, timing belt tension adjustment MUST be made via the Water Pump using the recommended service tool. Once fitted to the engine block, the automatic timing belt tensioner is to have no further contact with any tools.

ALL adjustments are to be made via the water pump.

Ensure that the tension indicator is lined up as per the vehicle manufacturer's specification on the automatic timing belt tensioner. This is essential in generating the correct amount of tension on the timing belt.

Any type of lever or retaining devices that make contact with the automatic timing belt tensioner may result in premature FAILURE. This can then lead to catastrophic ENGINE FAILURE! Any attempt to lever the Automatic Timing Belt Tensioner will VOID ALL DAYCO TIMING BELT KIT WARRANTY.
