DAYCO AFTERMARKET TECHNICAL INFORMATION

Subject: **KTBA281, KTBA281H
KTBA281HP & KTBA281HP1 TIMING KITS**

TI0020
Released 04/10/2016

Mitsubishi Challenger/Triton 4D56T

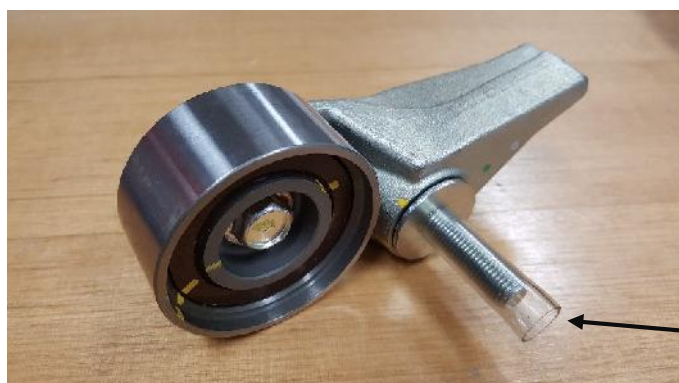
This family of timing kits contains a Timing Tensioner Assembly (Dayco P/N KT190) for the main timing drive, and is supplied with a special Allen Shoulder Bolt held captive by a plastic sleeve (refer below).

Plastic captive sleeve as supplied on bolt

Upon removal of the plastic captive sleeve, it is important that the spacer washer remains in its intended place on the assembly and is included when fitting to the engine. Further, the bolt must be tightened down to a torque of **48Nm +/- 6Nm**. Once fitted, check that the tensioner assembly pivots freely about its mounting point.

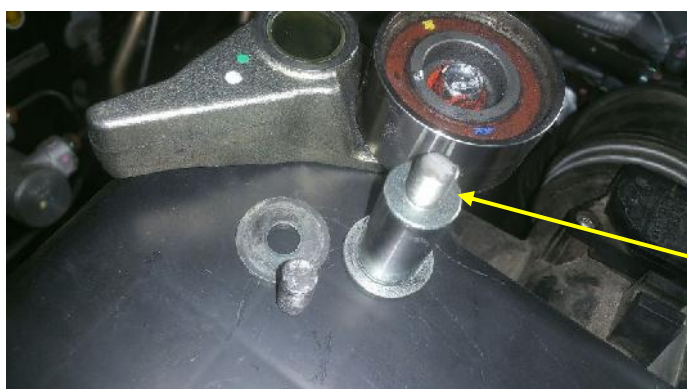
If these additional procedures and checks are not carried out there is a potential for the mounting bolt to fail through fatigue, resulting in engine damage (an example of such a failure shown in photo left). Any claims with evidence of this type of failure will not be covered under warranty.

Mounting bolt failure through fatigue
